Structure Number: 19
Original Use: Housekeeping Residence
Present Use: Personnel Quarters (duplex)
Construction Date: 1921
Architect: Unknown
Number of Levels: Three (including basement)
Total Area: 7,646 square feet
Plan Shape: Rectangular
Basic Construction: Wood frame
Uses per Floor: Basement

Structural Maintenance and Treatment Plan - Exterior Quarters

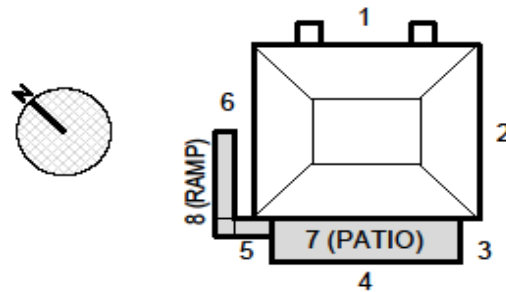
MODERATE REPAIRS ARE NEEDED FOR THE COVERED PATIO & ASSOCIATED STAIRS. DETERIORATION OF THE EXPOSED WOOD HAS TAKEN PLACE OVER TIME. IN ADDITION, THE EXTERIOR PATIO FLOOR HAS A SIGNIFICANT SAG & WARP TO IT. THE PATIO & ASSOCIATED STRUCTURE HAVE FALLEN AWAY FROM THE BUILDING ITSELF. THE ASSOCIATED FOUNDATION WORK FOR THESE PATIOS HAS CRACKED IN VARIOUS LOCATIONS. THESE ITEMS SHOULD BE ADDRESSED IN THE NEAR FUTURE TO PREVENT FURTHER STRUCTURAL DAMAGE.

THE EXISTING ROOF AND ASSOCIATED FRAMING WERE FOUND TO BE IN GOOD CONDITION WITH THE EXCEPTION OF THE ROOF OVER THE PATIO. MODERATE REPAIRS ARE NEEDED FOR THIS ROOF AND ASSOCIATED FRAMING. ROOF CURRENTLY HAS A SIGNIFICANT 'BELLY' TO IT THAT IS CLEARLY VISIBLE FROM THE OUTSIDE. REPLACEMENT OF THE WARPED ROOF & ASSOCIATED ROOF FRAMING IS SOMETHING THAT SHOULD BE ADDRESSED IN THE NEAR FUTURE.

EXTERIOR ITEM	PROBLEM IDENTIFIED	PROBLEM LOCATION																				RCMD	PHOTO	
		1	2	3	4	5	6	7	8	9	10	11	12	13	14	15	16	17	18	19	20			
Structural - Foundation																								
Concrete Foundation Wall - Exterior	Problem 1 - Minor																							
	Wall Cracking - Moderate	●	●	●	●	●																	C2	2, 3
	Wall Cracking - Major			●	●	●																	C2	1
Wood Floor Framing - Patio Stairs & Ramp	Problem 1 - Minor																							
	Deterioration of Exterior Wood Stair - Moderate	●			●																		W2	4
	Deterioration/Warping of Existing Patio/Ramp Floor Framing - Major								●														W3	7
Wood Floor Framing - Patio	Problem 1 - Minor																							
	Deterioration of Exposed Wood Patio Framing - Moderate			●	●	●		●															W2	1
	Warping of Existing Patio Floor Construction - Major							●															FW1	5
Structural - Roof																								
Wood Roof Framing	Problem 1 - Minor

Warping of Existing Patio Roof Construction - Moderate							●															RW1	6
	Problem 1 - Major

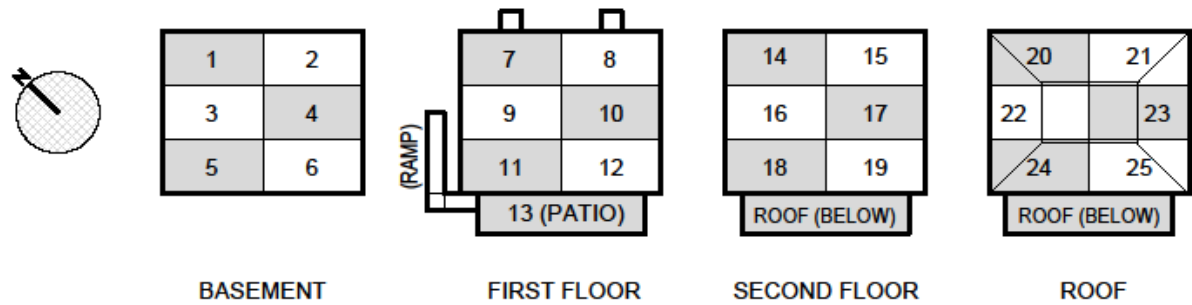
MODERATE REPAIRS ARE NEEDED FOR THE WOOD FLOOR FRAMING AS NOTED BELOW. MUCH OF THE EXPOSED WOOD FRAMING HAS UNDERGONE SEVERE DETERIORATION. ADVANCED STRUCTURAL DETERIORATION & SPLITTING OF THE EXISTING FIRST FLOOR SUPPORT BEAMS WAS FOUND AS NOTED BELOW.

MODERATE REPAIRS ARE NEEDED FOR ROOF FRAMING AND ASSOCIATED ROOF BOARDS. MINOR DETERIORATION OF THE EXISTING ROOF FRAMING & ASSOCIATED FLOOR BOARDS WAS FOUND AS NOTED BELOW.

Interior Item	Problem Identified	Problem Location																														RCMD	Photo
		1	2	3	4	5	6	7	8	9	10	11	12	13	14	15	16	17	18	19	20	21	22	23	24	25	26	27	28	29	30		
Structure - Floors																																	
Concrete Floor Slab - Basement	Floor Cracking - Minor		●		●		●																								C2		
	Problem 1 - Moderate																																
	Problem 1 - Major																																
Wood Floor Framing - First & Second Floors	Warping of Existing Floor Construction - Minor													●																	FW1		
	Deterioration of Existing Wood Floor Framing - Moderate							●	●	●	●	●	●	●																W2/W3	12		
	Problem 1 - Major																																
Structure - Walls/Columns																																	
Structural Walls - Concrete	Problem 1 - Minor																																
	Wall Cracking - Moderate	●	●			●	●																							C2	8, 9		
	Wall Cracking - Major					●	●																						C2	10

Structural Walls - Brick	Wall Cracking - Minor																				●	●								MB2	14		
	Wall Cracking - Moderate	●	●	●	●																								MB2	11			
	Problem 1 - Major																																
Structure - Roof																																	
Wood Roof Framing	Deterioration of Existing Wood Roof Framing - Minor																				●	●	●	●	●	●				W2	13, 14		
	Problem 1 - Moderate																																
	Problem 1 - Major
